# Rutherford High School Pool Investigation Report

## RUTHERFORD BOARD OF EDUCATION

Rutherford Public Schools, 176 Park Avenue, Rutherford, NJ 07070  
PSA Project Number 7984

9 April 2019  
(Final Report Issue)

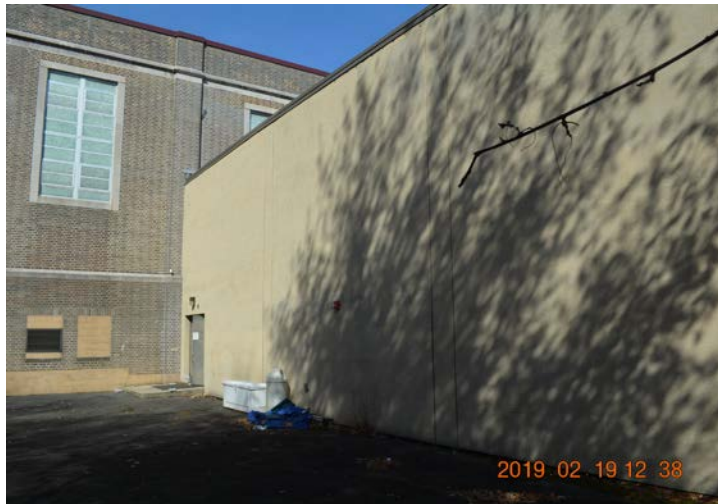
**Photo 1:** The 1980 Pool Addition was built up against the south wall of the 230 Gym that had been built in 1922. This is the wall facing Elliott Place. The pool exit doors are at the far edge.

The wall finish is Exterior Insulation and Finish System (EIFS). The central zone of this wall has become delaminated, and the stucco like surface can be physically moved if you push on it.

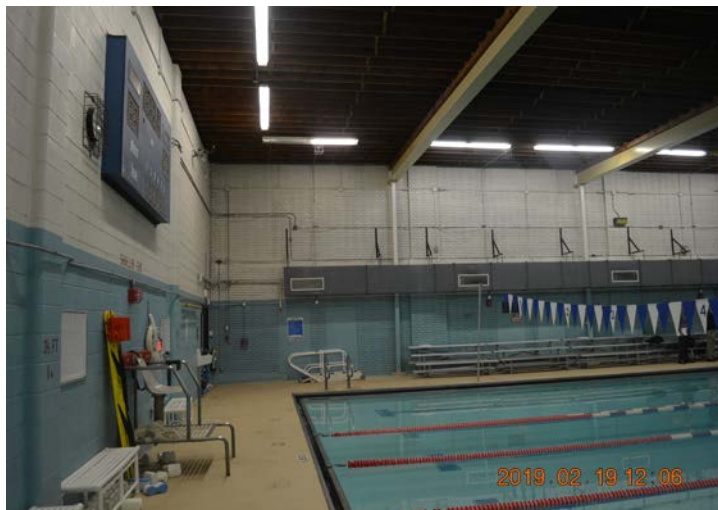
**Photo 2:** Just inside the double doors in the photo above, the 239 Gym exterior wall has been painted. The columns supporting the main girders above are located up against the original building's exterior wall.

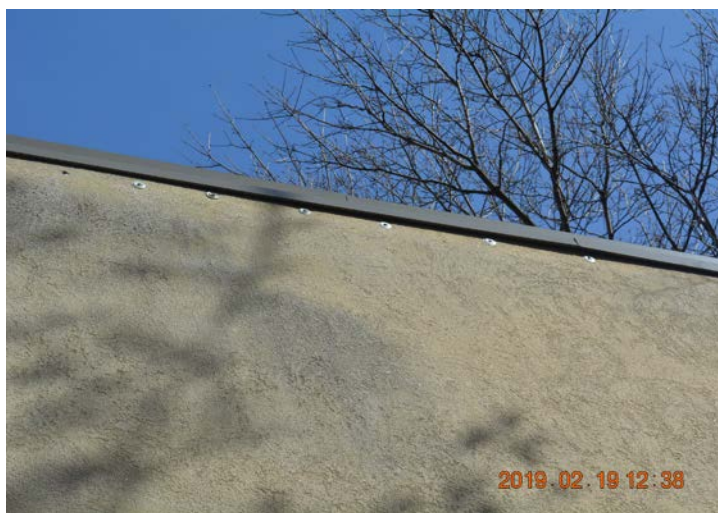
**Photo 3:** The top edge of three wall shown in Photo 1 has been mechanically fastened over the delaminated zone to prevent gross separation until the wall system can be replaced.

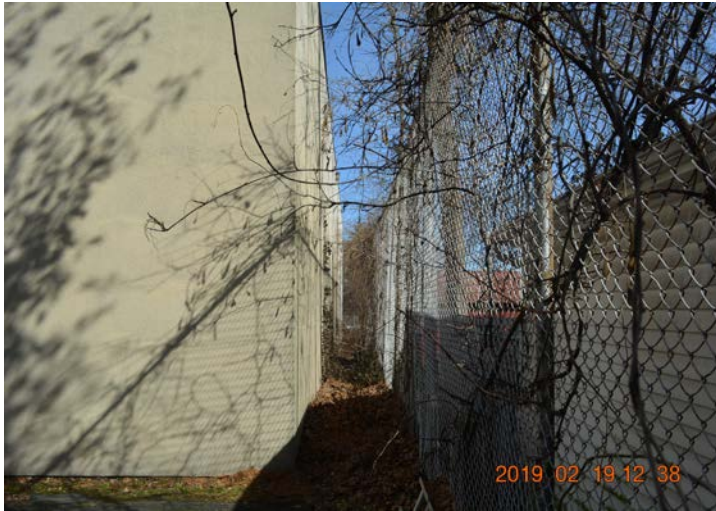
**Photo 4:** The south wall is very close to the fence at the property line, providing only limited narrow access to the surface for maintenance or renovation work.

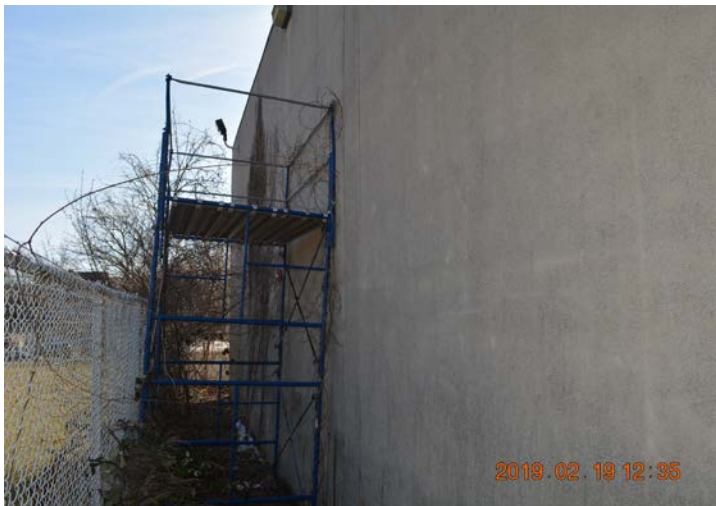
**Photo 5:** The east wall faces the field with distance to the fence line restricting access at this side also.

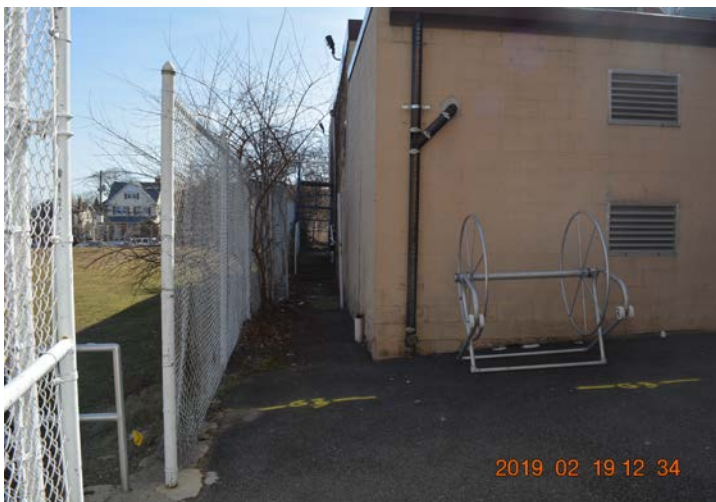
**Photo 6:** Backing up from the previous view, the wall of the Boiler Room and Filter Room beyond are exposed concrete masonry (CMU) walls, painted. They do not have the EIFS applied finish like the pool enclosing walls have.

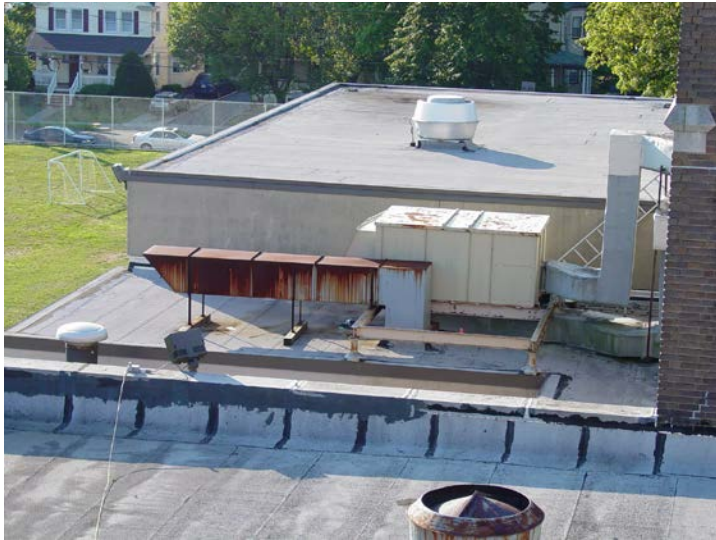
**Photo 7:** Eastern part of Pool Addition Roof: Roof over the pool space is the high portion beyond, in this view. The round roof top exhaust fan over the pool is visible. The lower section nearer and visible in this view is the area over the filter room before the white roof was put on in 2009.

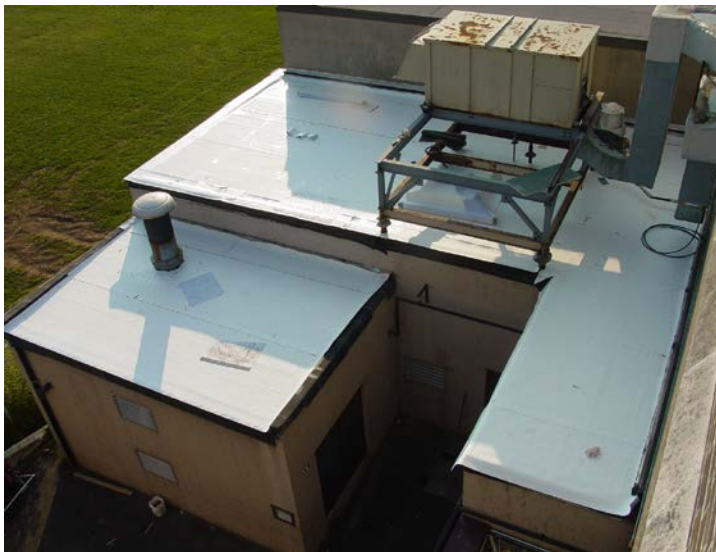
**Photo 8:** View of the new roofs over support spaces as they neared completion with the white reflective membrane. The replacement occurred only over the support spaces, and not over the main pool roof.

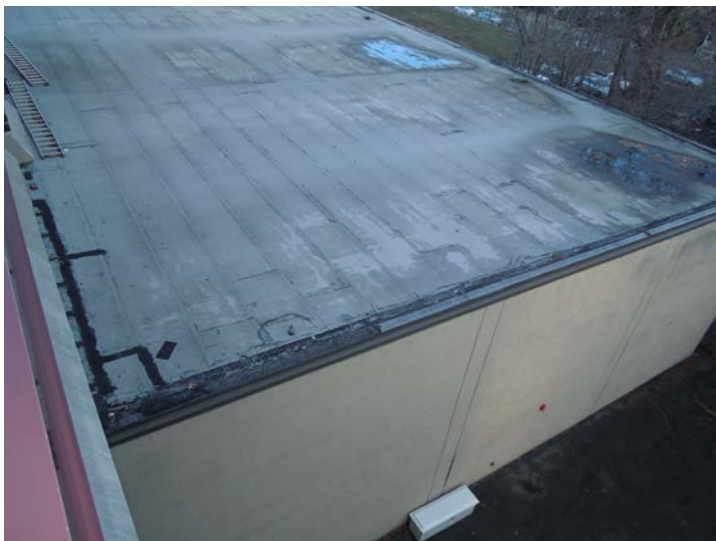
**Photo 9:** Western section of the main pool roof as it is today. Dark seam repairs are visible in lower left corner, and ponding is observed at the southern edge. The lighter shading strips running perpendicular to the roll lap lines are the high points above the steel girders below. Those lines of less deflection in the roof deck make the ponds occur in localized depressions between the main girder lines. A new roof application could utilize tapered insulation along with local sump kits at the drains to eliminate the ponding.

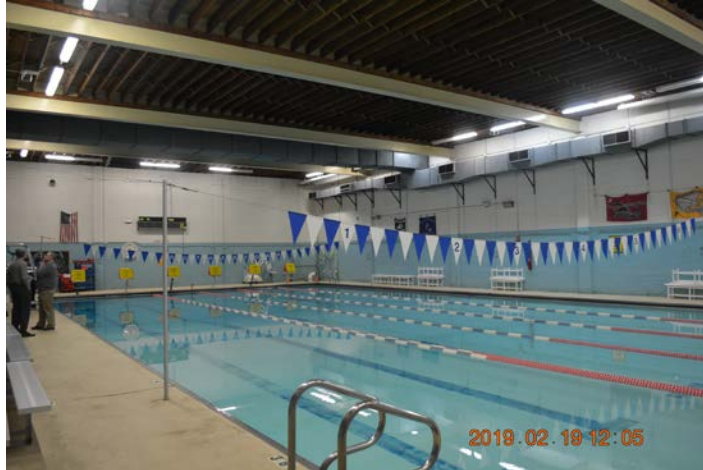
**Photo 10:** Main Pool Space Interior View: Main girders cross the space. Wood roof rafters span to ledger blocks on the beam sides. The pool has six lanes, with the starter platforms visible at the far pool end. Three tiers of metal bleachers are just off the photo to the left side. Existing supply ductwork is wall mounted at both side walls. General lighting is located only along the edges, where the fixtures can be serviced from the side deck areas.

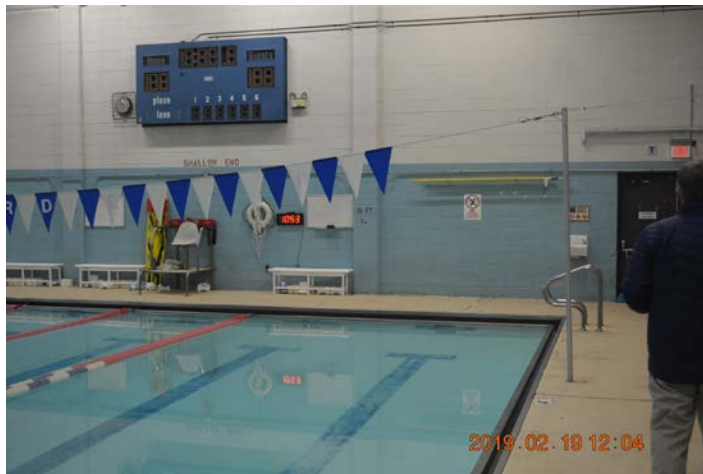
**Photo 11:** Opposite End wall, with Scoreboard: Note the pole supporting the cross pool flag line cable. The guy cable extending from pole top to the right side is actually fastened to the wall mounted duct work that is just outside the photo edge. It really should be routed properly to a wall anchor point, like that on the other side.

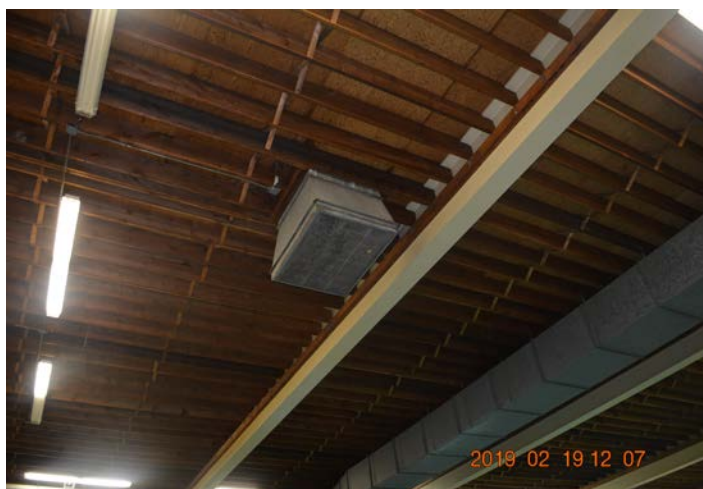
**Photo 12:** Single point exhaust register at roof. This system pulls out room air with its odors and heat. The existing exhaust setup has no means for recovering the thermal energy in the air being pulled out and exhausted to the exterior.

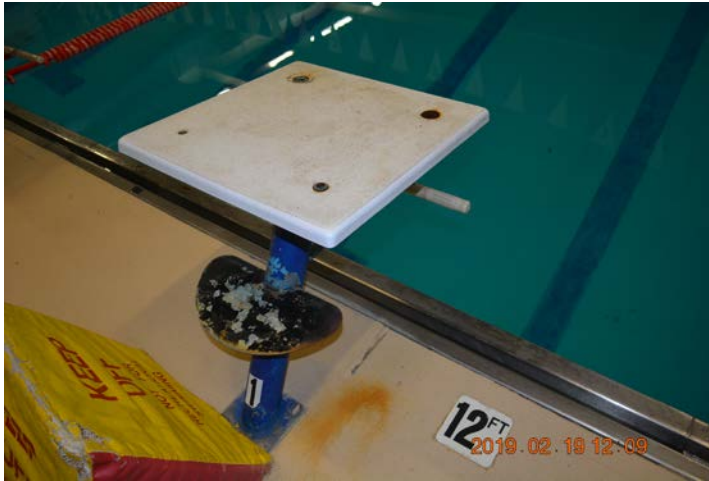
**Photo 13:** Typical starter platform. These are of rigid permanent type, non-removable. Finish on bases are in poor condition. Hardware is corroded. Foam safety cps are in poor condition also.

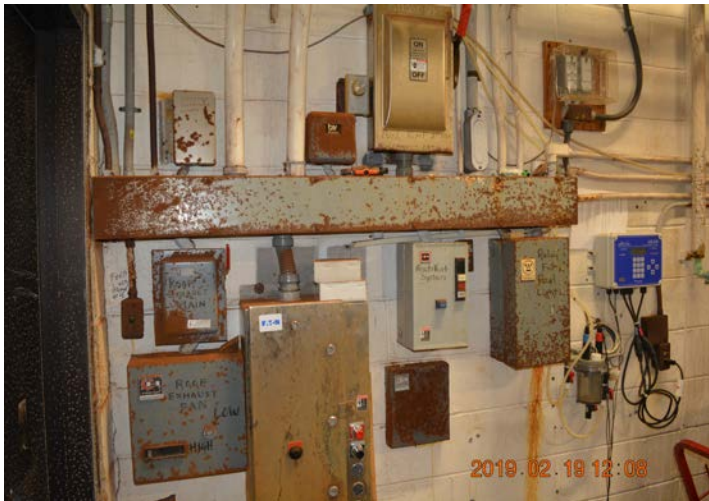
**Photo 17:** Electrical Center within the Filter Room, immediately adjacent to the chemical storage location. Metal components are incurring extreme corrosion. Replacement of selected devices has become necessary in the past in order to restore functionality.

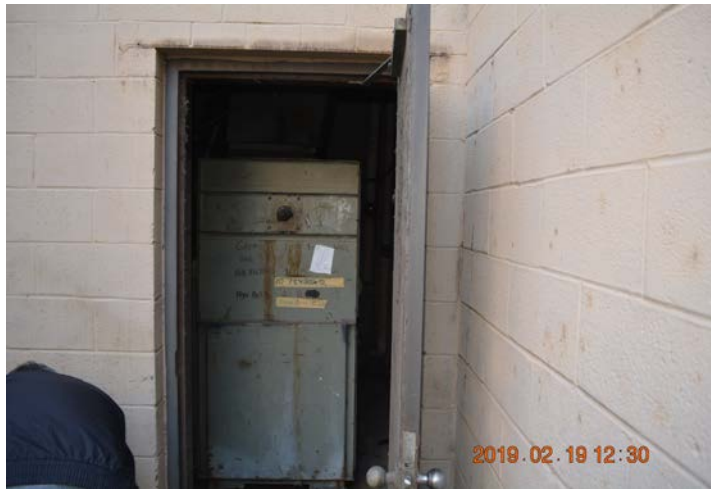
**Photo 19:** The existing air handler machine room is only accessible from the exterior door shown here. Minimal space is available around the equipment, barely sufficient to squeeze along one side and one end. Serviceability is impaired.

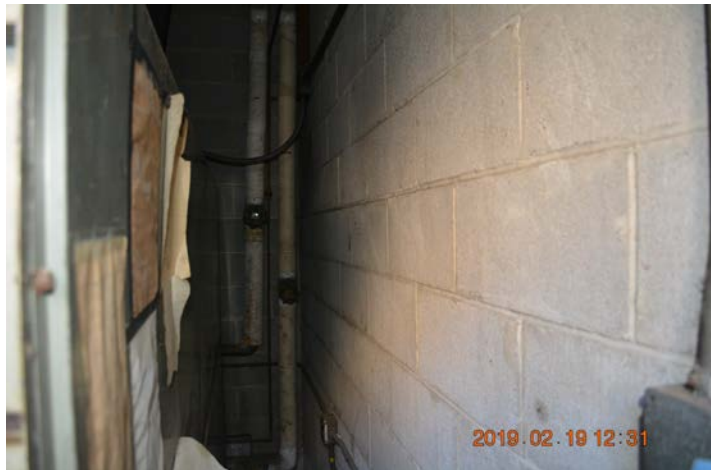
**Photo 20:** Air handler room limited access around equipment. Replacement would require partial removal of the exterior wall.

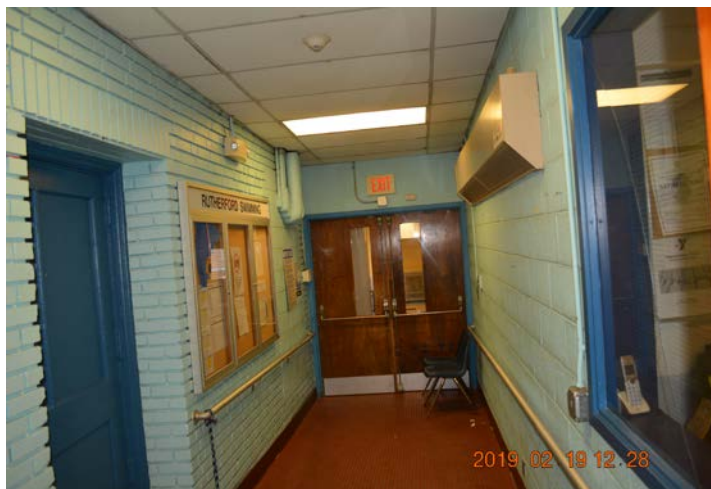
**Photo 21:** Existing corridor out to Locker Rooms and Showers, located through the end doors and to the left down a second ramp. Rubber flooring with raised disc tread pattern is moderately worn.

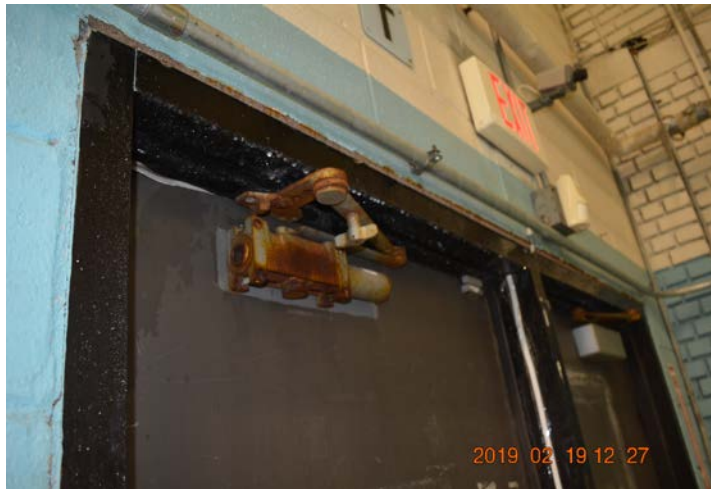
**Photo 22:** Pair of exit doors toward Elliott Place. Door hardware base metal suffers in the corrosive atmosphere. In cool weather, the refrigerated metal surfaces have water freely condensing on all surfaces.

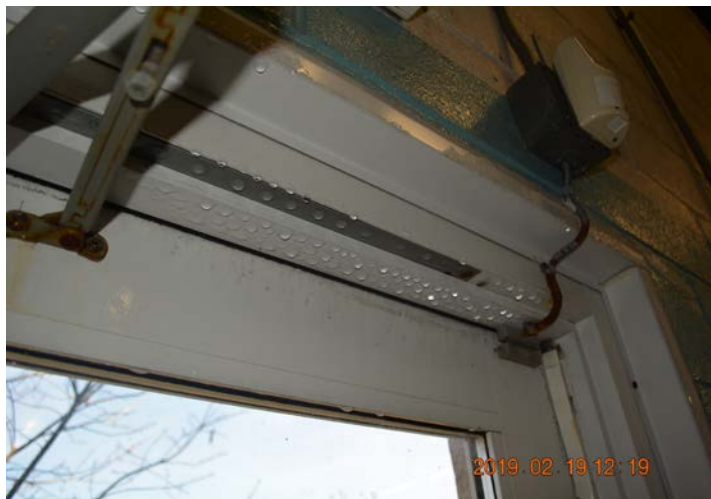
**Photo 23:** Exit door toward field. Condensed moisture is readily visible. Any carbon steel base metal items quickly corrode under this aggressive condition.

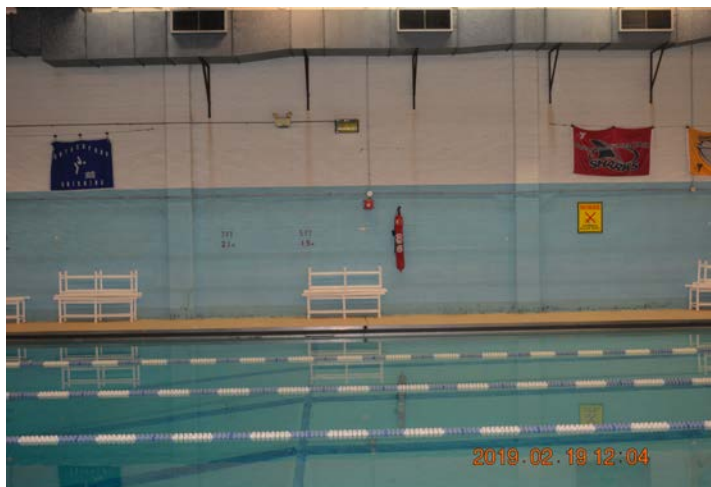
**Photo 24:** All metal items and fasteners suffer from corrosion as can be seen by the rust streaks below the duct support brackets on the opposite wall.

Also note the wall finish damage along the base course of masonry from the adverse effects of chemical vapors in the room air. The vapors are heavier than the room air, and collect close to the water elevation.

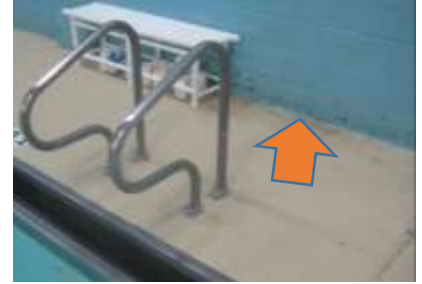
**Deteriorated Paint**

It is highly corrosive and deleterious to building components as well as human lung tissue. Evidence of long-term nitrogen trichloride pollution may be observed in the deteriorated paint at the base of the natatorium walls.

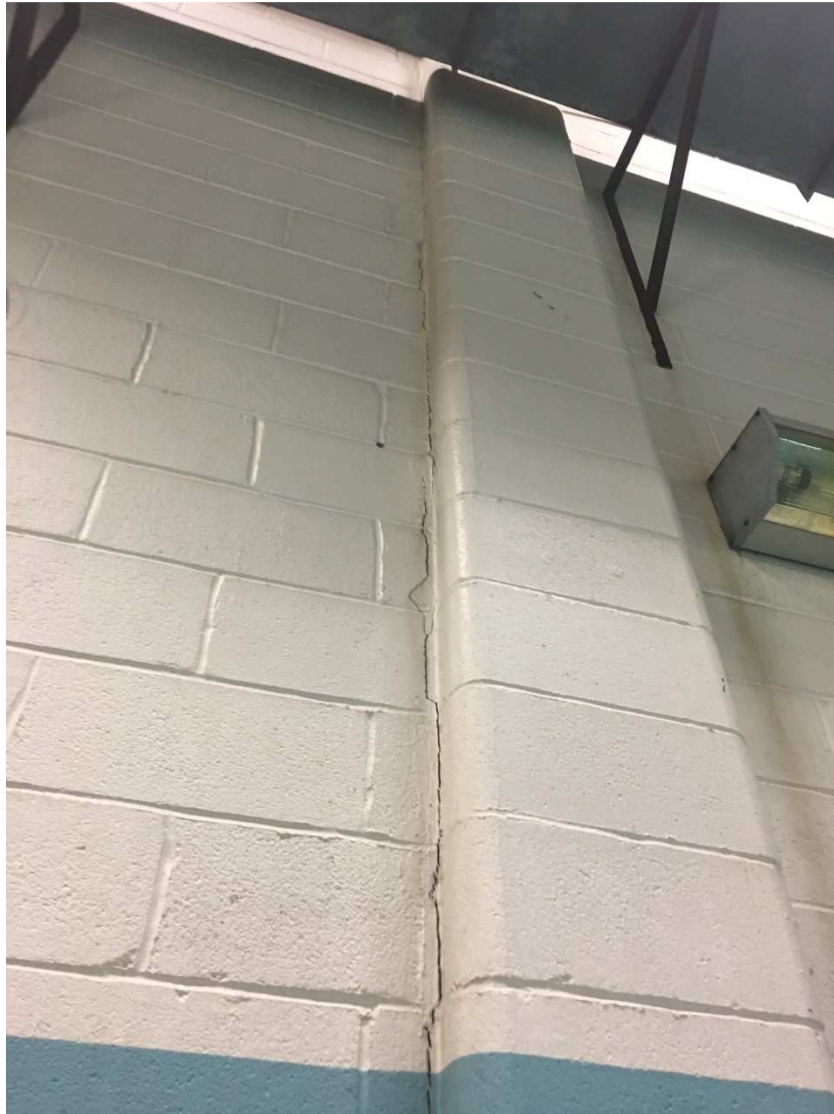
Photo 1 – Crack between pilaster and masonry. Typical at pilasters on exterior side of pool enclosure

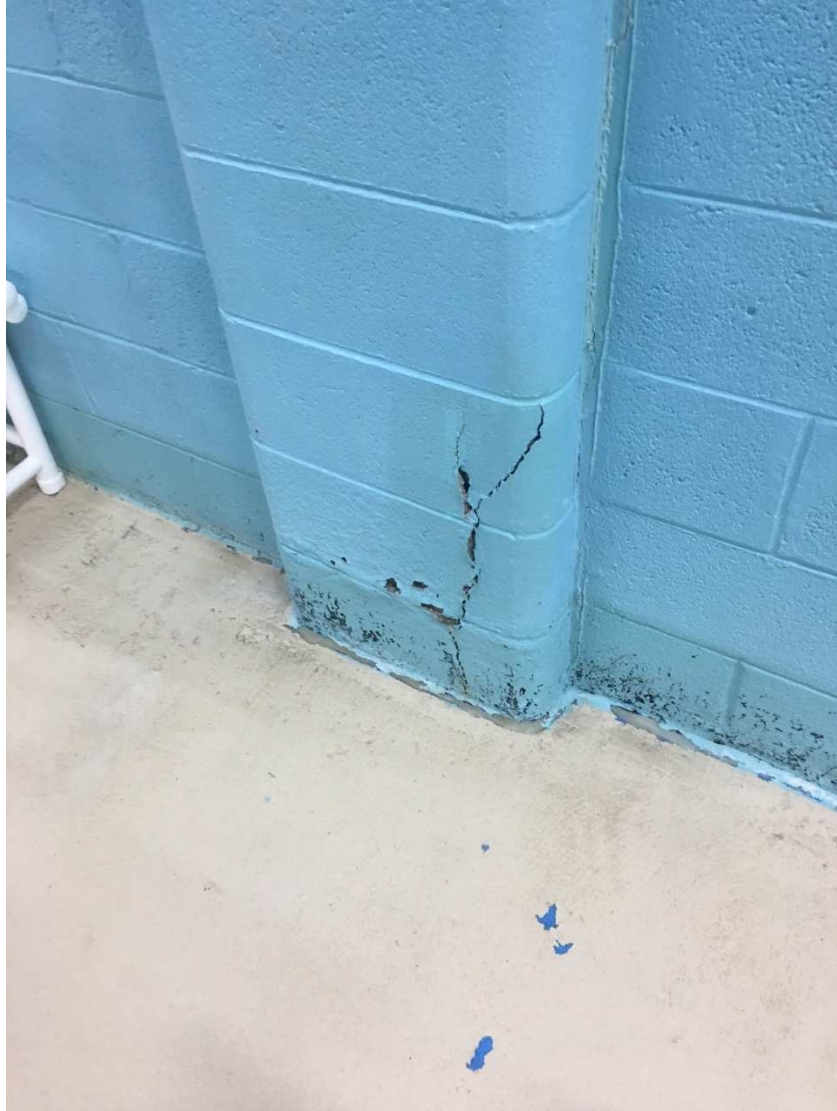
Photo 2 – Damage at base of pilaster

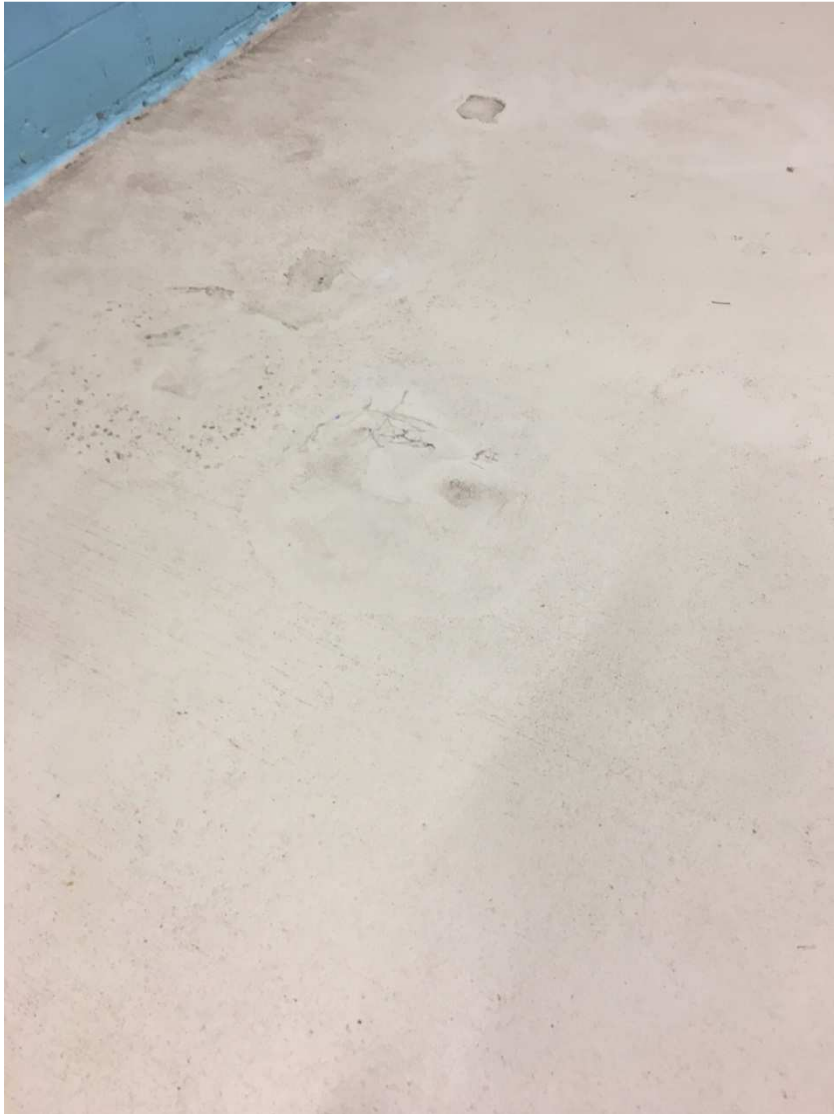
Photo 3 – Repair in pool deck with start of spall.

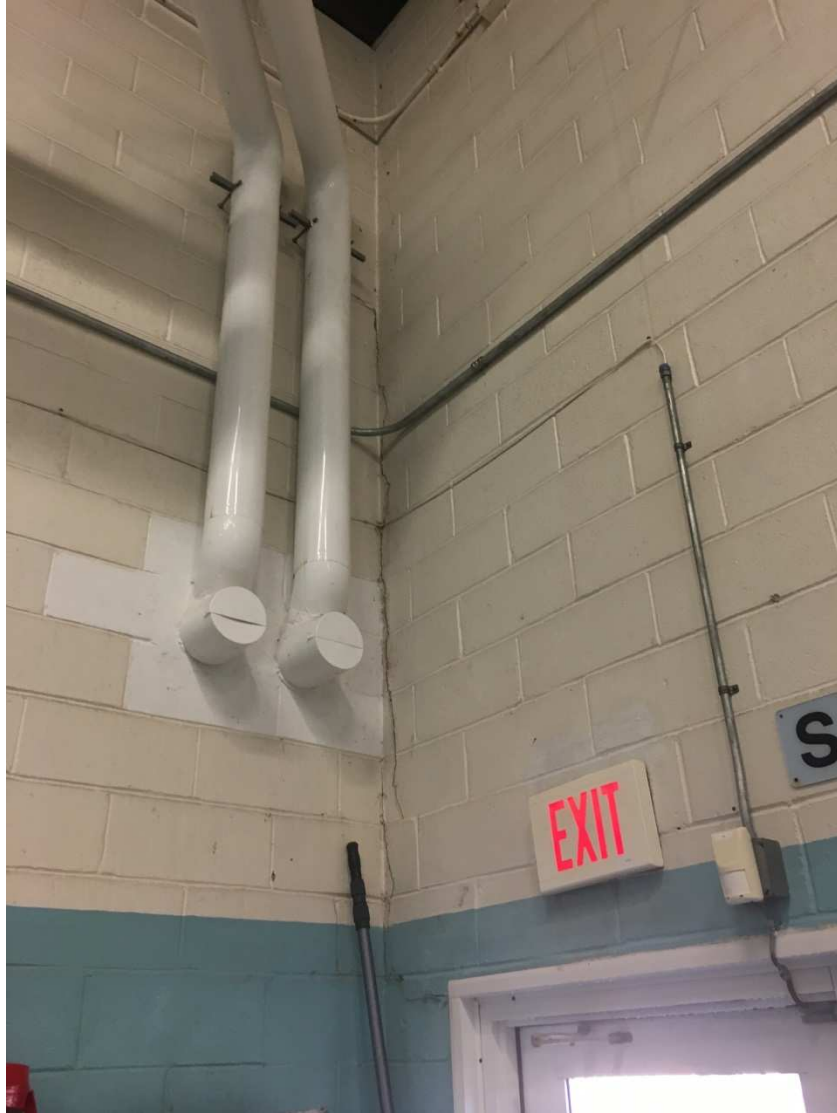
Photo 4 – Northwest corner, note crack in corner of walls.

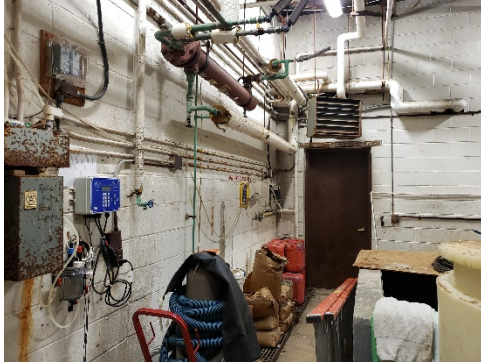
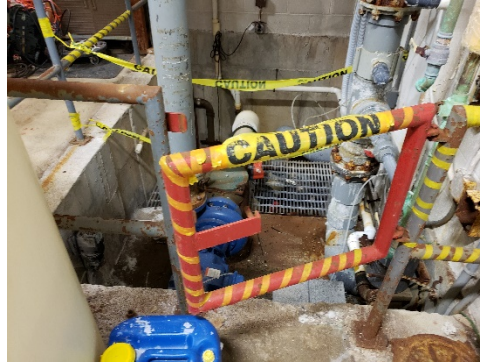
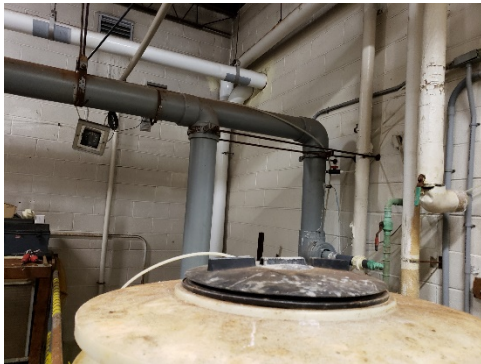
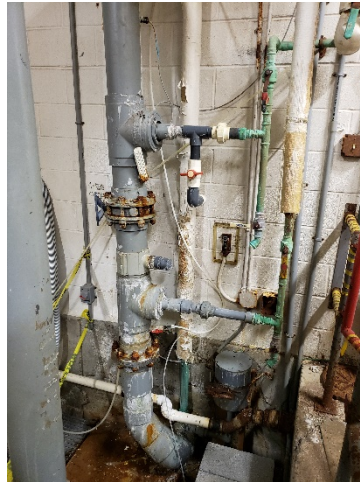
The ventilation in the filter room is not sufficient, as evidenced by the corrosion on the exposed copper pipes and the hand rails. A small wall exhaust fan is located near the ceiling on the north wall and discharges outside.

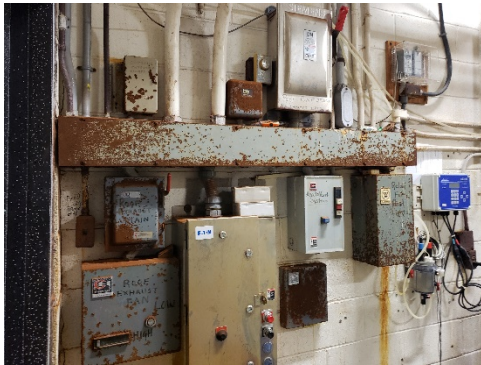
The electrical disconnects located in the filter room are corroding from the chemical usage in the room.

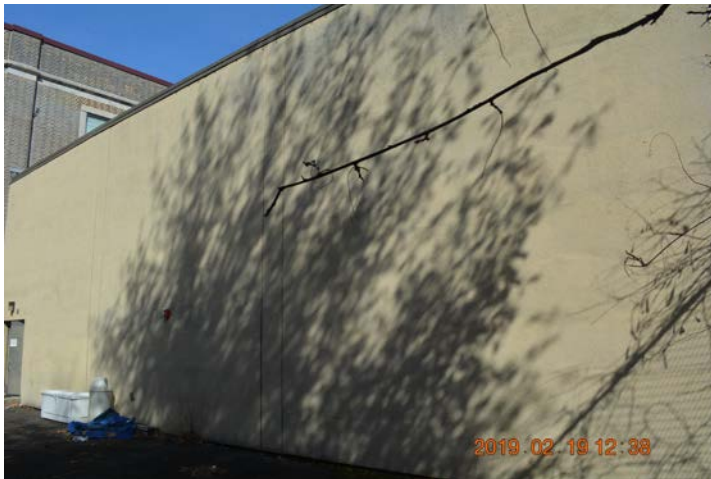
**Photo 2:** Pool facility exterior wall is constructed of concrete masonry units (CMU) in a bearing wall configuration, surfaced on the outside face with an Exterior Insulation and Finish System (EIFS).

The EIFS should be replaced within 3 to 5 years.

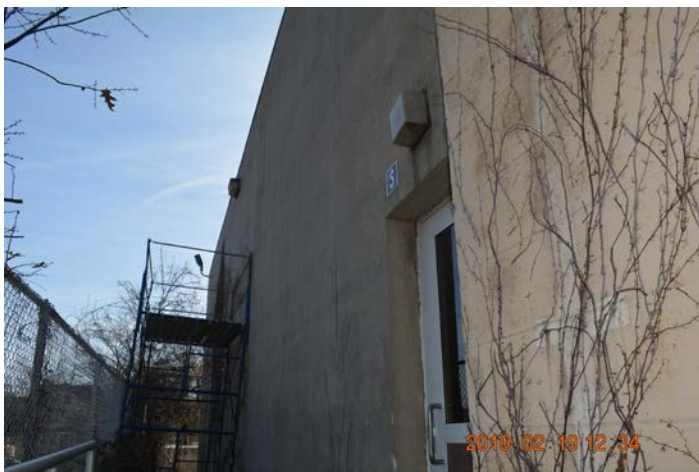
**Photo 3:** Pool facility exterior EIFS & CMU block wall transition. The pool enclosing walls have some insulating value from the EIFS. The exposed CMU walls around the support spaces seen in the right side of this view have little thermal resistance, and are not compliant with current Energy Conservation Code requirements.

At the time selected for replacement of EIFS on the pool enclosing walls, it would be prudent to apply new EIFS on the support space walls also, at that same time.
