# Rutherford High School Pool Investigation Report

## RUTHERFORD BOARD OF EDUCATION

Rutherford Public Schools, 176 Park Avenue, Rutherford, NJ 07070  
PSA Project Number 7984

9 April 2019  
(Final Report Issue)

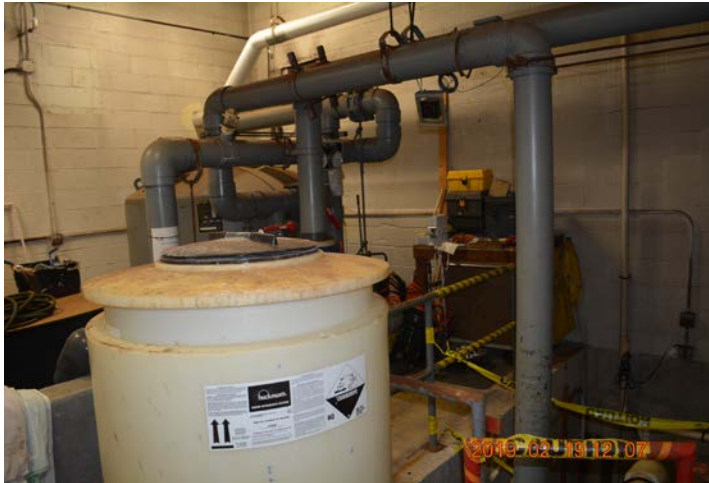
**Photo 14:** Filter Room, view of filter and water quality equipment arrangement.

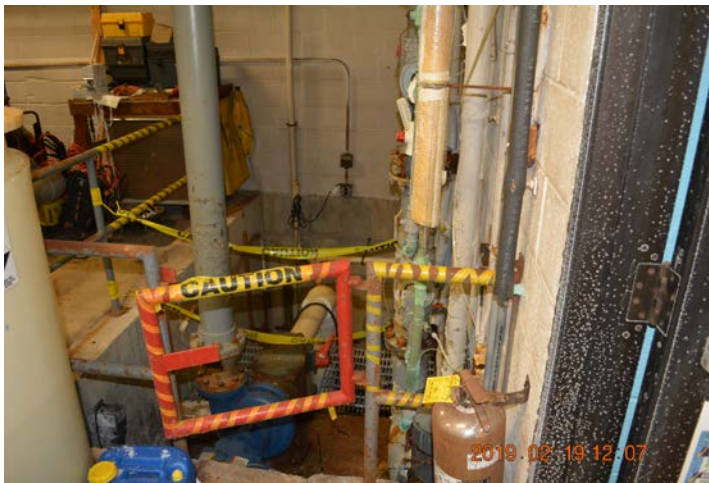
**Photo 15:** Filter Room sump area.

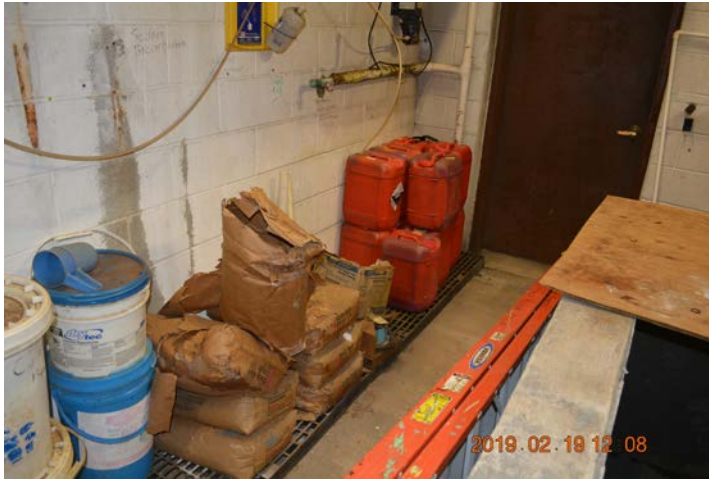
**Photo 16:** Exposed chemical storage area in the filter room.

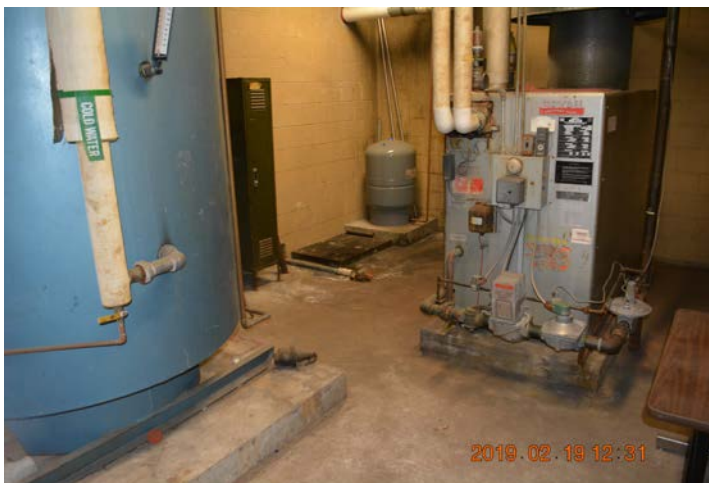
**Photo 18:** Boiler Room. This unit supplies heat for pool water, pool space room air heating, and it also supplies domestic hot water to the Elliott wing of the High School.

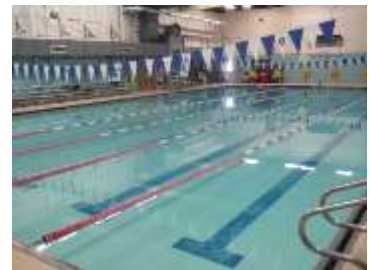
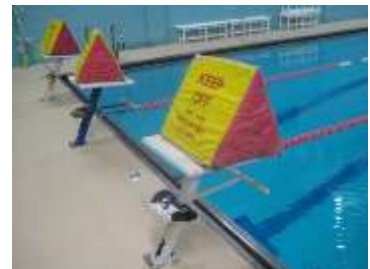
The starting platforms are outdated, deteriorated and unsightly but based on our visual inspection, they are safe to use. The other deck equipment, (grabrails, lifeguard chairs, etc.) were in apparent good condition.

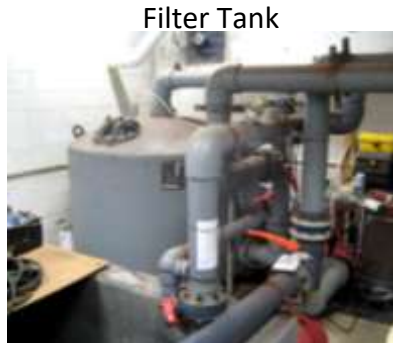
Filter Tank

The existing filtration system is a high-rate sand type with a capacity to filter all of the pool water once every 6.16 hours. The current code requires a capacity to filter the water in six hours, making the system marginally compliant. The filter is not original to the project and, insofar as could be determined, is in fair to good condition.

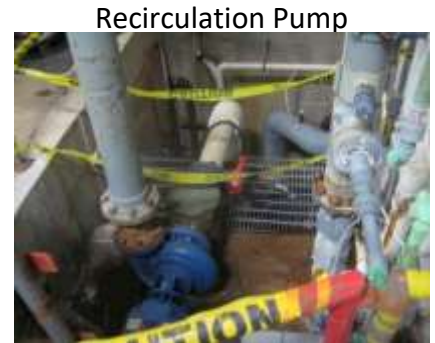
Recirculation Pump

The recirculation pump is not original to the project and, insofar as could be determined, is in fair to good condition.

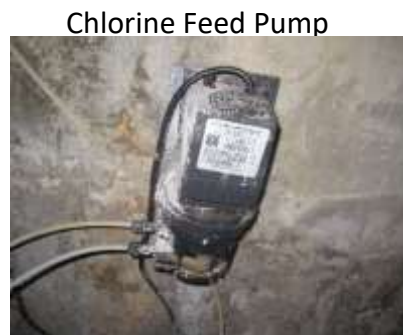
Chlorine Feed Pump

All of the water chemistry components have been replaced, probably multiple times over the years. The current installation is functional but generally unprofessional. Chlorinator tubing is hung haphazardly around the room instead of being conducted in protective conduit or converted to rigid PVC pipe. The chlorine feeder shows signs of frequent leakage and accumulated dried chlorine deposits. The feed pump for the acid (pH control) was not operational. (Staff reported that a replacement was on order). A bulk chlorine storage tank is on site with the required primary and secondary containment. Filling such tanks safely is typically performed by a bulk truck and trained delivery driver. The awkward juxtaposition of the filter room vs. the nearest truck access, combined with the presence of 5-gallon chlorine containers warrants confirmation from staff that the tank is indeed filled by tank truck and that the 5-gallon containers are on hand for emergencies. Filling the bulk tank manually from 5-gallon containers would be very dangerous and if it were learned that this is happening, an alternative chlorine program should be developed immediately.

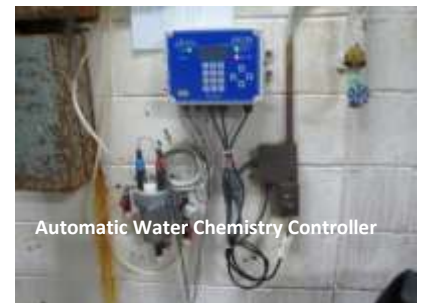
Automatic Water Chemistry Controller

The automatic water chemistry controller was on line and appeared to be functioning properly during our visit. The unit is among the less sophisticated available but is nevertheless perfectly suitable for the task.

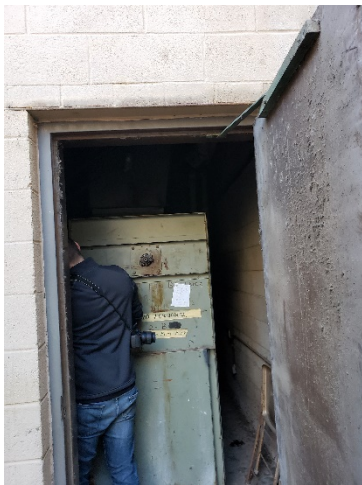
Mechanical Room

The space is served by a heating and ventilating unit. The unit is located in a mechanical room located outside the pool building. We were unable to verify the unit size as there is not sufficient access in the mechanical room to maneuver around the unit. On the door side of the room, there is approximately 1.5' of access and there is even less on the remaining three sides.

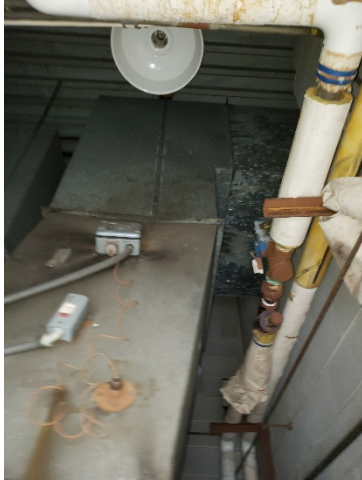
Supply Duct

The unit has an outside air duct (going to the roof of the mechanical room), a return air duct and a supply air duct. It is heated with a hot water coil. The hot water coil is fed from a boiler that serves the pool room space heating, the pool water heating and the domestic hot water for the Elliot wing. The boiler is a nominal 50 HP boiler with a natural gas input of 2100 MBH and heating output of 1680 MBH (80% efficient).

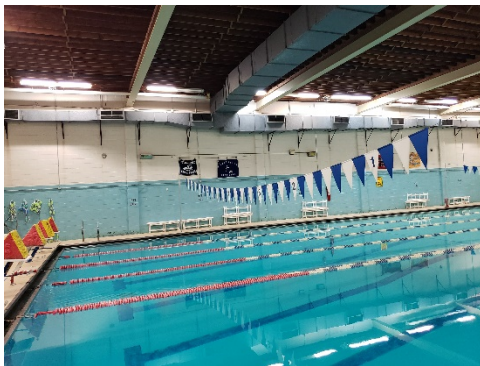
Supply Air Duct

The supply ductwork then routes through the wall, above the corridor, enters the pool room and travels along the ceiling to the far (east) wall. The ductwork then splits into two branches running along the east wall and is distributed into the space through eight supply diffusers. The return duct is routed along the west wall of the space and returned to the air handler through six return registers. A single exhaust fan is mounted on the roof and has a single duct drop into the space for exhaust.

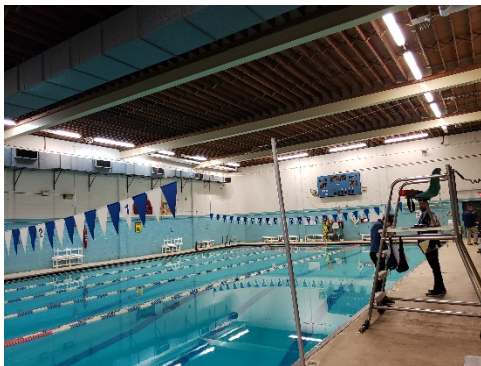
Lighting is provided by 1'x8' fluorescent fixtures mounted to the underside of the roof joists. The lights are arranged directly above the pool edge. Light level readings were taken along the deck on all sides of the pool. Light levels ranged from 13.3 foot-candles (fc) to 21.4 fc, representing a uniformity index of 1.6:1.

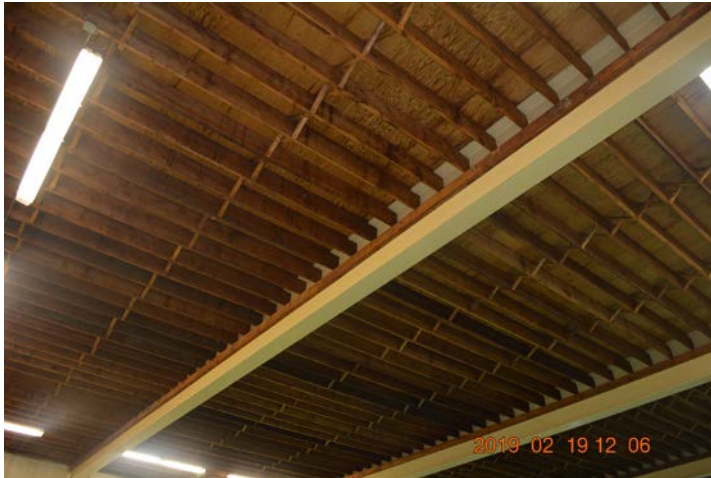
5. The pool roof structure itself uses solid wood joists spanning to ledgers bolted to steel main girders, all covered by plywood decking. Based on visual observation from below, it is felt that the basic structure is can be expected to be still serviceable. (See Photo #1 in section 6.2)

**Photo 1:** Pool roof structure is wood framed with plywood decking, exposed to view over the pool space.

Lighting is located around the pool perimeter so that the fixtures can be serviced from the deck around the pool edge. Any alternative lighting approach would need to be located around the pool perimeter for the same reason.

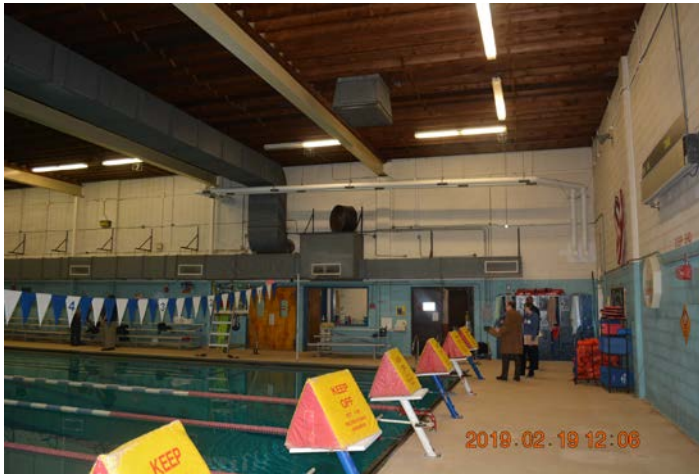
1. The pool enclosure is windowless in all spaces except that the pool office does have interior vision lights into the pool area and the corridor. The pool space has two direct exterior exit doors, (single door with vision light toward the field, and unglazed double doors toward Elliott Place). A pair of wood doors leads to the exit corridor, and a single wood door separates the pool office from the main pool space. All other doors relating to the mechanical support spaces are metal doors. (See Photo #4 in section 6.2)

**Photo 4:** Pool Enclosure Interior Windows & Doors
